Development of the JHU ROV II Power and Electronics Housings

Katie Mao

23 August 2017

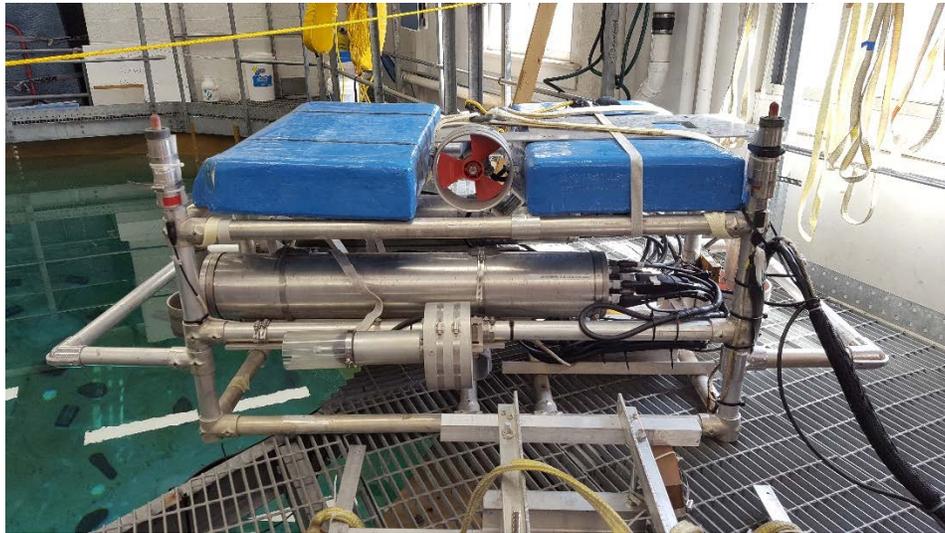
Figure 1: JHU ROV sitting on deck in the Dynamics System and Control Laboratory (DSCL)

The Dynamical Systems and Control Laboratory (DSCL) in Johns Hopkins works on developing control and navigation algorithms for ROVs. Because field deployment is time-consuming and costly, the DSCL has a tank within the lab for testing as well as a testbed ROV, the JHU ROV, in the lab to work on (Figure 1).

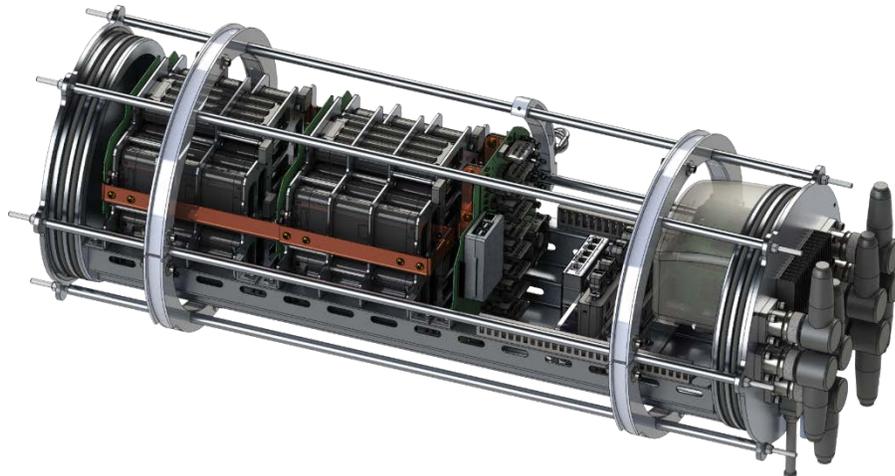
Figure 2: Rendering of the Power Housing without the exterior tube

With the bulk of the CAD for the power housing finished (Figure 2), attention turned to the manufacturing phase. An important consideration before ordering stock was choosing materials. Since the outer structure of the housing would be exposed to water, it was imperative that materials resistant to corrosion through long-term water exposure be chosen. Taking into account price and weight, the two materials considered were 316 Stainless Steel and 6061 Aluminum. While 316 is cheaper than 6061, it also has three times the density.^{[2], [3]} The weight of fasteners such as bolts and nuts is negligible and 316 was chosen. However, for parts such as the six rods surrounding the housing, material weight is an important factor in keeping the weight of the housing as low as possible.

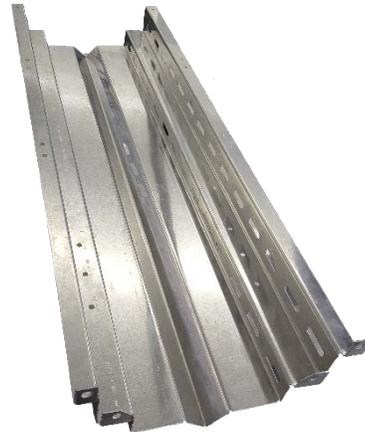
Figure 3: Manufactured Bent Sheet Metal Chassis

After choosing materials, a Bill of Materials (BOM) for both COTS parts and stock for manufacturing was compiled and parts were ordered. The following month was primarily spent on manufacturing the pieces seen to the right and below (Figure 3, Figure 4). It was quickly determined that the acrylic tube and the

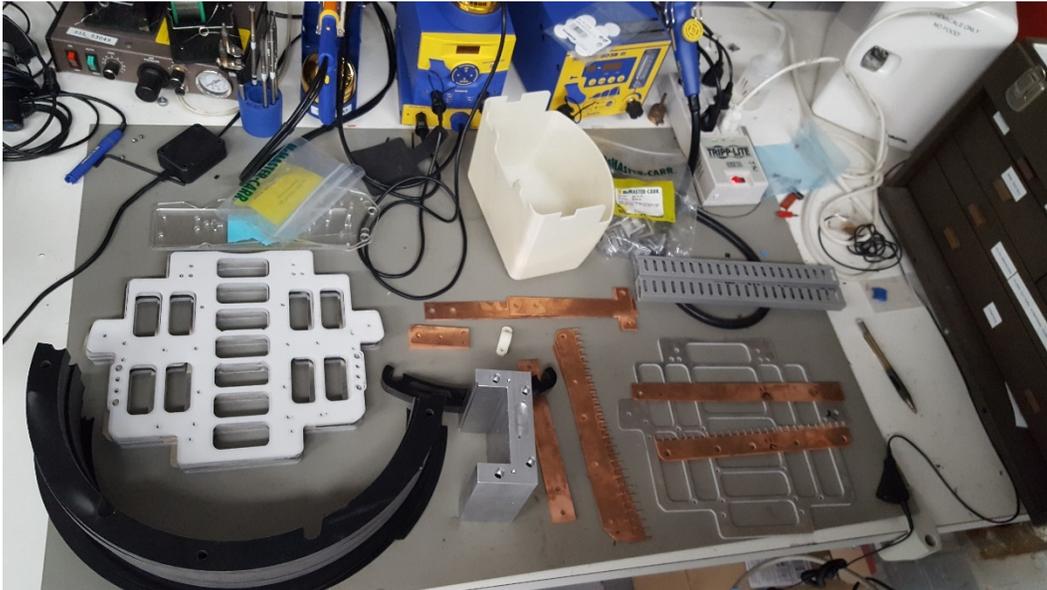
Figure 4: Manufactured parts of the Power Housing

aluminum endcaps could not be manufactured to the proper tolerances by two summer interns. Instead, drawings of the parts were made and sent to professional machine shops to be manufactured. Unfortunately, many of the COTS parts and parts sent for machining did not arrive by the end of the summer. The circuit board for the batteries was also yet to be designed and manufactured. Thus, it was impossible to begin assembling and testing of the subsystems of the power housing.

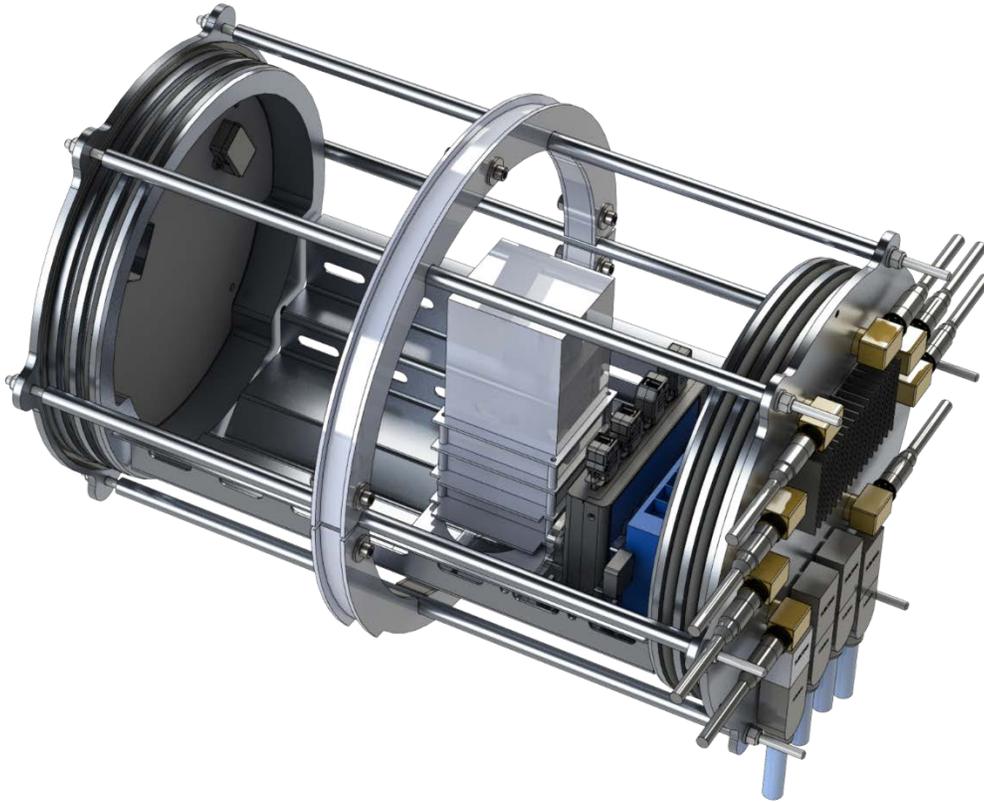
Figure 5 shows part of the interior of the Electronics Housing. The outside of one endcap of the electronics housing holds four power/ethernet connectors mounted on the bottom, three female heads and one male head. The male head takes power from the power housing to minimize the possibility of injury from touching an exposed pin. One of the other connectors transmits power/ethernet, while the last two are left as spares. There are also eight utility connectors placed in a radial pattern along the edge, all with female heads. Finally, a heatsink and a pressure release valve are mounted near the center of the endcap. On the inside of the

endcap are three Vicor DC-DC converters, covered by an ULTEM heatshield to maximize safety.

Adjacent to the Vicors are the MOXA and Ethernet switch, mounted vertically to the chassis via acrylic trays. Next to the MOXA and Ethernet is the CPU stack, with a weatherboard mounted horizontally underneath. Muffin fans are placed strategically to the sides of the Ethernet tray to circulate air through the housing. Finally, on the interior of the opposing endcap are the MicroStrains. The CPU stack was placed behind the MOXA and Ethernet Switch to allow for better hardware access during repairs. While this places the stack closer to the MicroStrain, it was determined that there is enough distance between the two components that effects would be minimal.

Figure 5: The interior of the electronics housing

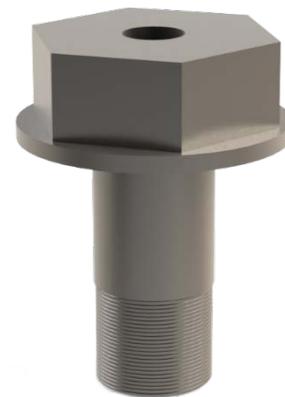
To remedy this problem, a plug (Figure 6) was designed that would fit the existing hole and allow for the connector to pass through while keeping the housing watertight. This plug would also be made of titanium to match metals with the endcap.

Figure 6: Rendering of the KVH Housing Endcap Plug

Initially, the plug threaded into the endcap with the connector able to spin freely inside the plug.

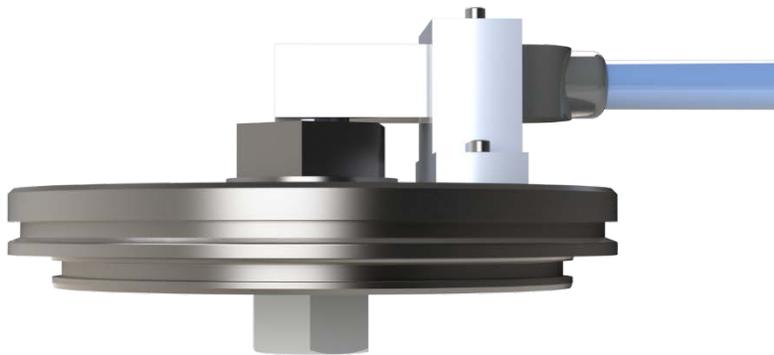
Unfortunately, it was quickly noted that the threads on the connector would not be long enough to pass all the way through the endcap. Attempting to fit a socket head through the hole of the endcap to attach a nut to the connector would require extra machining on the endcap itself, something to be avoided. Instead, the connector threaded into the plug and the plug and the connector together spun freely inside the endcap, with a nut on the end of the plug to keep it in place, as shown in Figure 7.

Another point of concern was the elevation of the connector and in turn, the connector whip. Because of the elevation, the whip is now cantilevered, giving it an extra range of movement. This could lead to a loosened or possibly lost connection during a dive. To minimize such concerns, a support piece was designed to keep the head of the whip at the same height as the connector

Figure 7: Rendering of the modified KHV Housing Endcap assembly

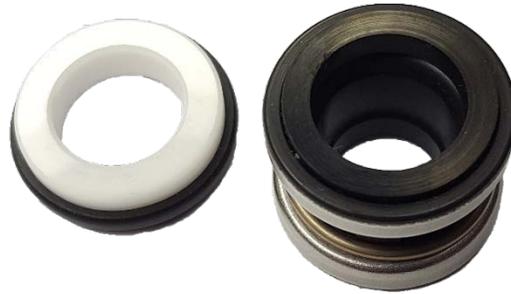
As expected, the lip seals that came installed in the thrusters failed at 14 ft. of depth. They were replaced with ceramic/graphite face seals (Figure 8) from John McCrane. A custom tool (Figure 9) was designed and manufactured to install these seals.

Figure 8: John McCrane ceramic/graphite Face Seals

It was noticed after the installation of the seals that the added height of the ceramic and graphite seals made

reassembly of the thruster more difficult, as more pressure had to be used to force the housings together. At the time, this issue was dismissed, but it would later have significant implications.

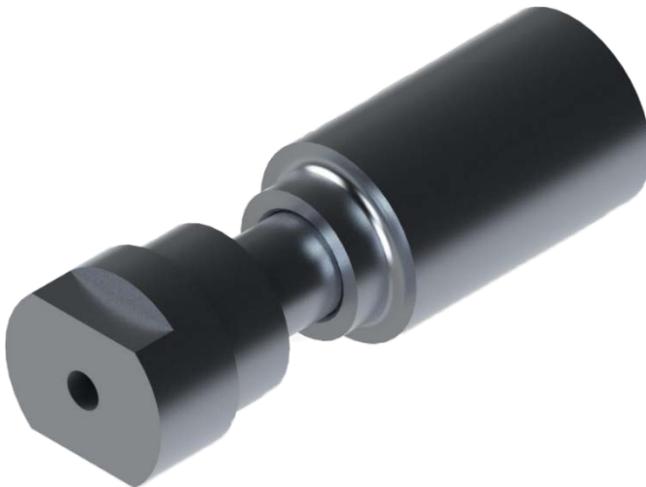
Figure 9: Rendering of the Face Seal Install Tool

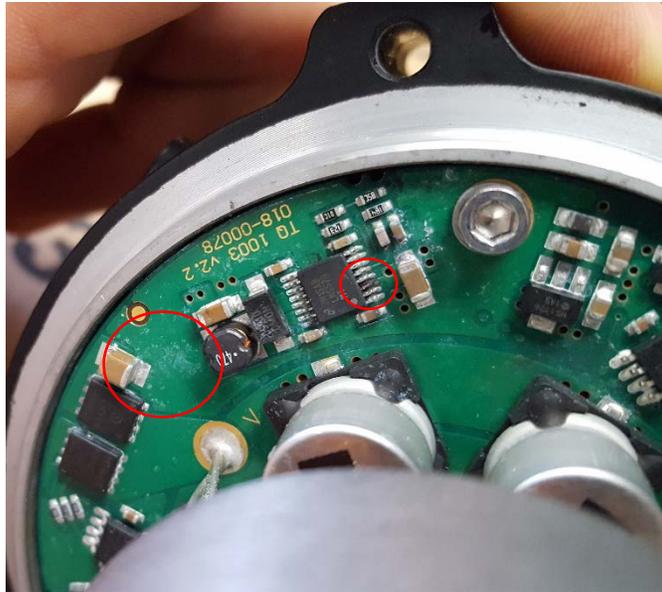
Attempting to run it saw no movement from the thruster despite being at the current limit of the power supply. Several minutes into testing, there was a sudden spike which likely signified a short. Retrieving and disassembling the thruster showed that the entire thruster housing had been flooded. Inspection of the circuit

board showed dried residue from the tank and what was likely several corrupted diodes (Figure 10). The circuit board was cleaned with diH₂O and alcohol then left to dry for a day in an attempted revival, which failed.

Figure 10: A section of the flooded circuit board. Water damage and corroded diodes have been highlighted.

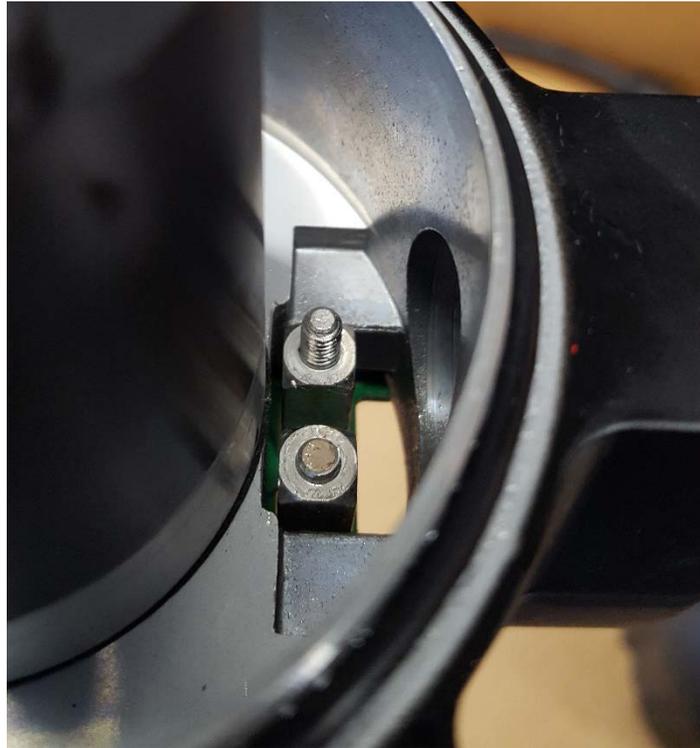
A second thruster was acquired to finish this thruster seal testing. The first thruster was attached to a power source through a series of cables designed in the lab. Instead of attempting to recreate these cables, they were simply transferred from the original thruster to the new one. While attaching the wire terminals to the terminal studs on the thruster, the nut was overtightened and the stud was sheared off (Figure 11). It was then noted that the studs were not aluminum as originally thought, but brass, a softer metal, with a solder coating to give them a silver sheen.

Figure 11: The sheared terminal stud of the second thruster

To repair this, the remains of the stud were faced off on the mill and the terminal was drilled into and threaded. The wire terminal was then reattached to the thruster and held in place with a bolt. An insulating foam sealant was used to shield the circuit board from any stray metal chips during the machining process.
